**West Chicago Environmental Response
Trust**

**Final Completion Report – Route
59 Bridge Area**

Kress Creek/West Branch DuPage River Site

November 2013

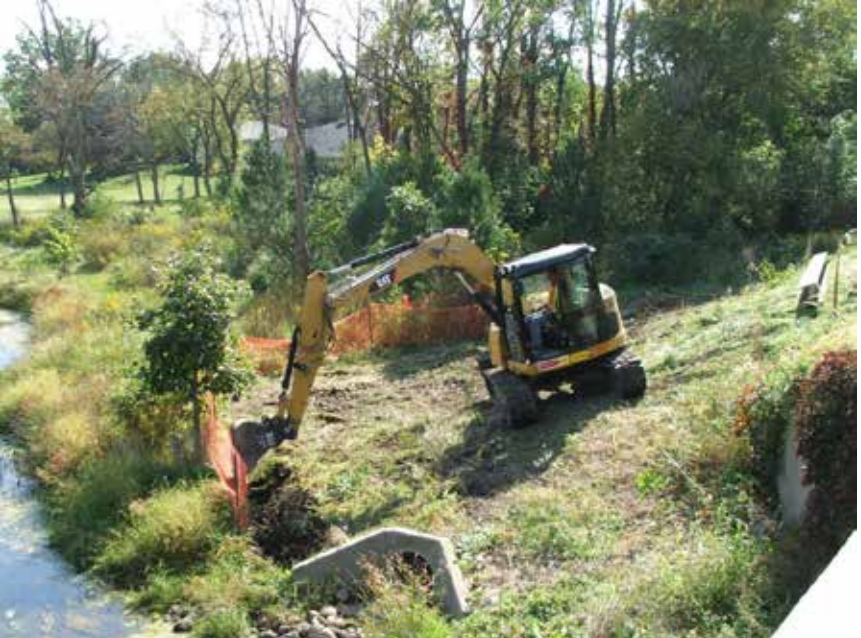
CLIENT: WCERT	SITE NAME: Kress Creek/West Branch DuPage River
PROJECT #: B0071043.0000	SITE LOCATION: DuPage County, IL
PHOTOGRAPH #: 1

DATE: 9/25/12	
DIRECTION: Southwest	
COMMENT: Clearing and grubbing in southwest corner (R4-5) of Route 59 Bridge area.

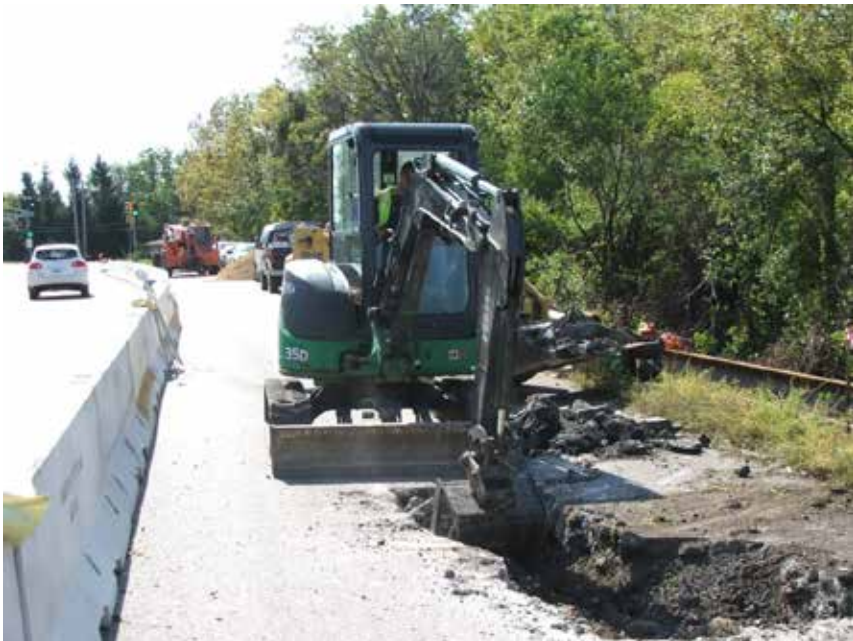
CLIENT: WCERT	SITE NAME: Kress Creek/West Branch DuPage River
PROJECT #: B0071043.0000	SITE LOCATION: DuPage County, IL
PHOTOGRAPH #: 3

DATE: 9/19/12	
DIRECTION: Northwest	
COMMENT: Asphalt removal in northwest corner (R3B-25) of Route 59 Bridge Area.

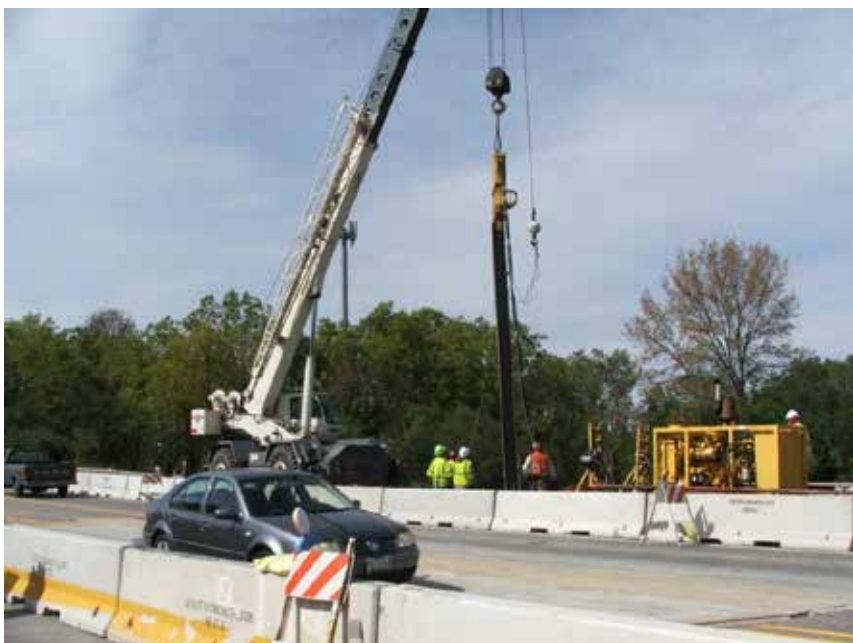
CLIENT: WCERT	SITE NAME: Kress Creek/West Branch DuPage River
PROJECT #: B0071043.0000	SITE LOCATION: DuPage County, IL
PHOTOGRAPH #: 4

DATE: 9/20/12	
DIRECTION: Northwest	
COMMENT: Installation of soldier piles in northwest corner (R3B-23) of Route 59 Bridge Area.

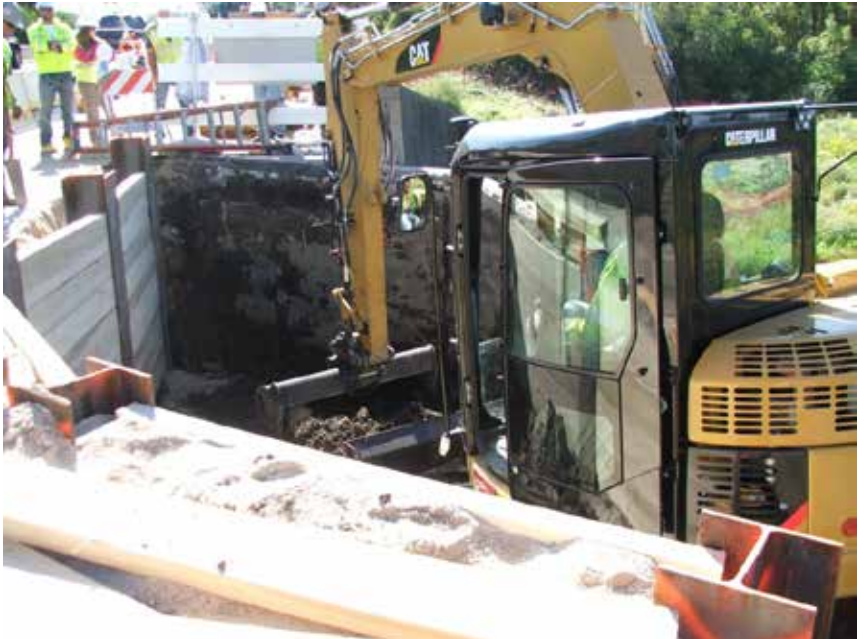
CLIENT: WCERT	SITE NAME: Kress Creek/West Branch DuPage River
PROJECT #: B0071043.0000	SITE LOCATION: DuPage County, IL
PHOTOGRAPH #: 5

DATE: 9/24/12	
DIRECTION: West	
COMMENT: Excavation of overburden material from northeast corner (R3B-25) of Route 59 Bridge Area.

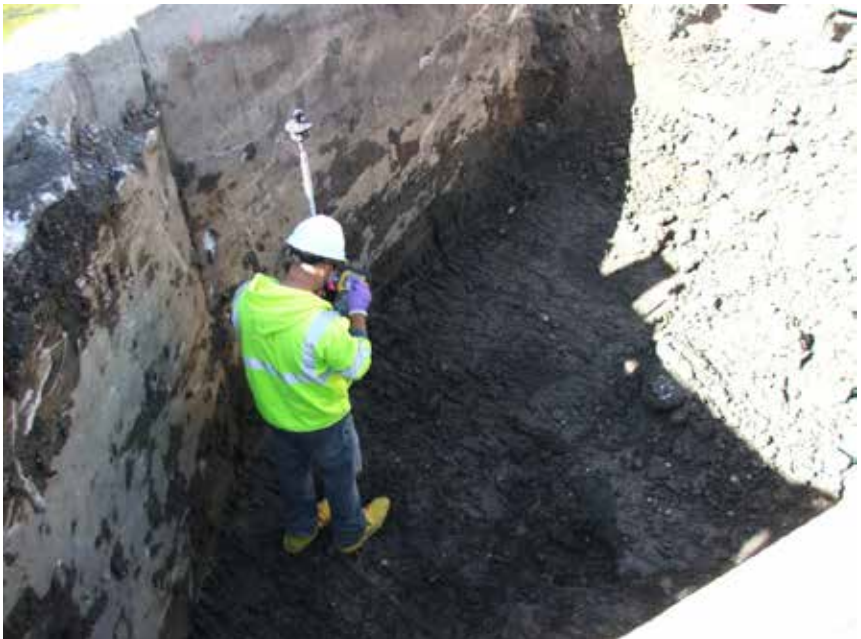
CLIENT: WCERT	SITE NAME: Kress Creek/West Branch DuPage River
PROJECT #: B0071043.0000	SITE LOCATION: DuPage County, IL
PHOTOGRAPH #: 9

DATE: 9/24/12	
DIRECTION: North	
COMMENT: Survey of verification point at the top of overburden material in the northeast corner (R3B-25) of the Route 59 Bridge Area.

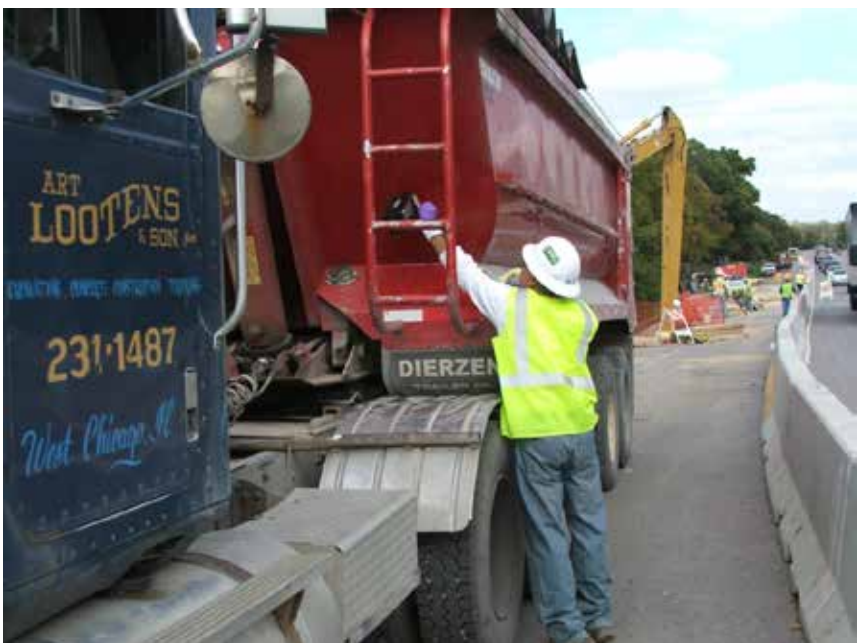
CLIENT: WCERT	SITE NAME: Kress Creek/West Branch DuPage River
PROJECT #: B0071043.0000	SITE LOCATION: DuPage County, IL
PHOTOGRAPH #: 10

DATE: 9/27/12	
DIRECTION: Northeast	
COMMENT: Gamma survey of truck hauling overburden material from the Route 59 Bridge Area to the Rare Earths Facility staging area.

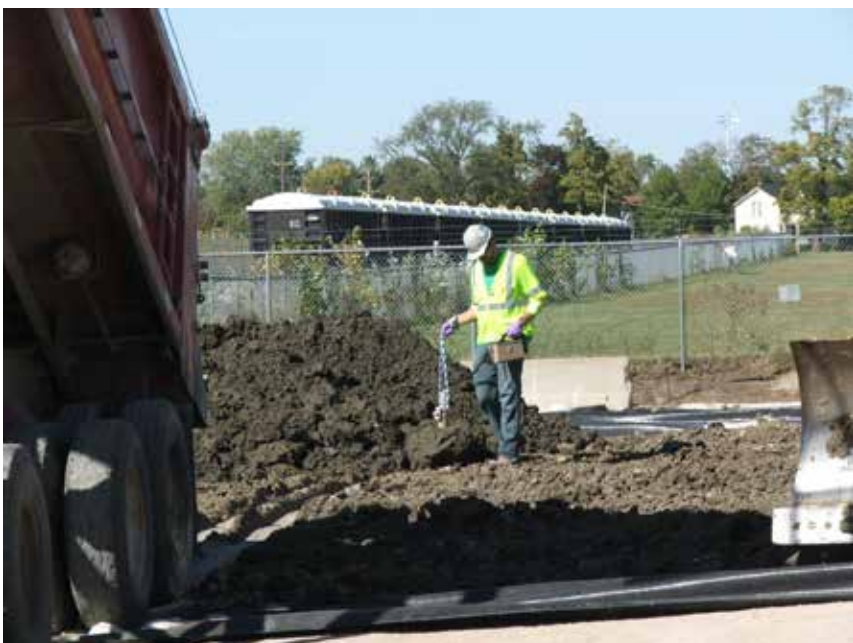
CLIENT: WCERT	SITE NAME: Kress Creek/West Branch DuPage River
PROJECT #: B0071043.0000	SITE LOCATION: DuPage County, IL
PHOTOGRAPH #: 12

DATE: 9/24/12	
DIRECTION: East	
COMMENT: Gamma survey of overburden material at the Rare Earths Facility staging area.

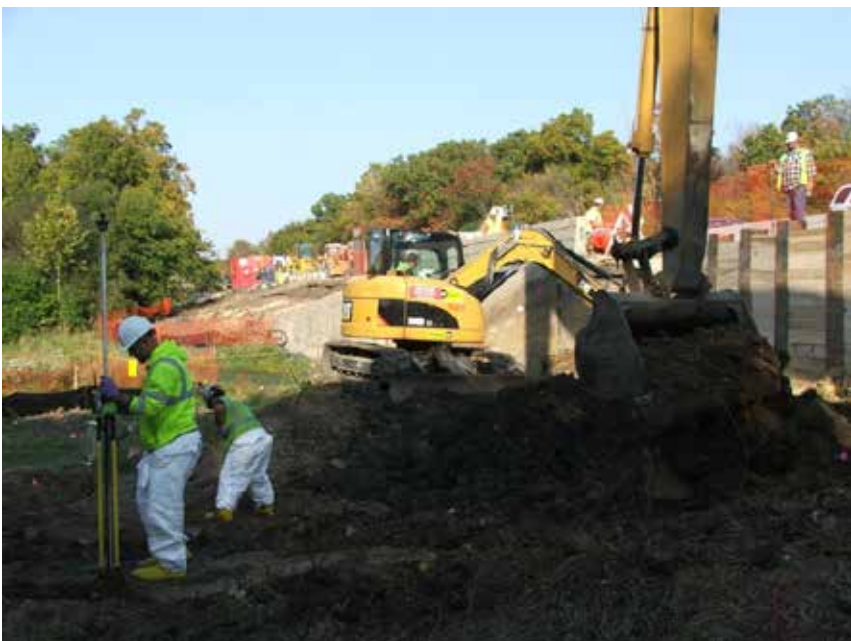
CLIENT: WCERT	SITE NAME: Kress Creek/West Branch DuPage River
PROJECT #: B0071043.0000	SITE LOCATION: DuPage County, IL
PHOTOGRAPH #: 14

DATE: 9/28/12	
DIRECTION: East	
COMMENT: Excavation of targeted material and survey of verification point at bottom of targeted material in northwest corner (R3B-23) of Route 59 Bridge Area.

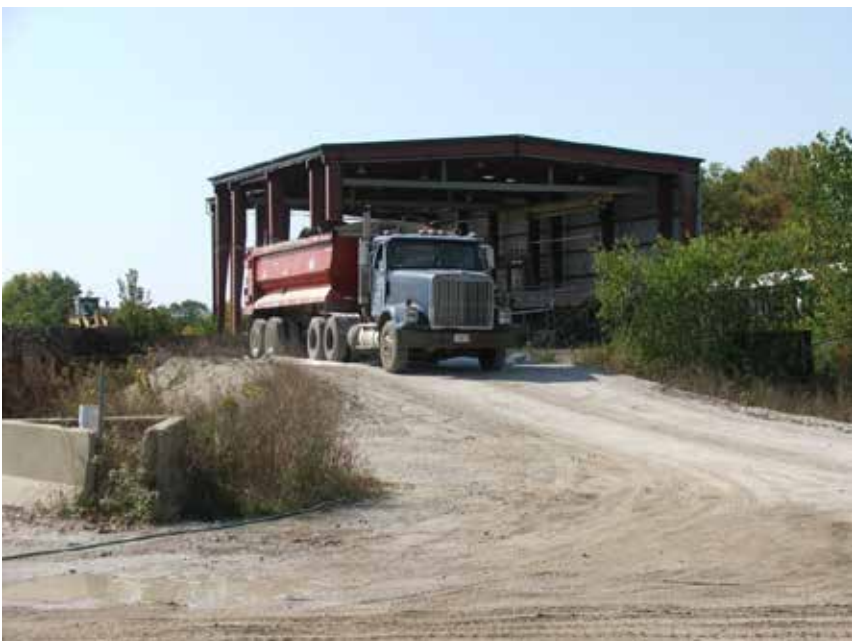
CLIENT: WCERT	SITE NAME: Kress Creek/West Branch DuPage River
PROJECT #: B0071043.0000	SITE LOCATION: DuPage County, IL
PHOTOGRAPH #: 16

DATE: 9/29/12	
DIRECTION: West	
COMMENT: Unloading targeted material from the Route 59 Bridge Area at the Rail Loading Facility in the Rare Earths Facility.

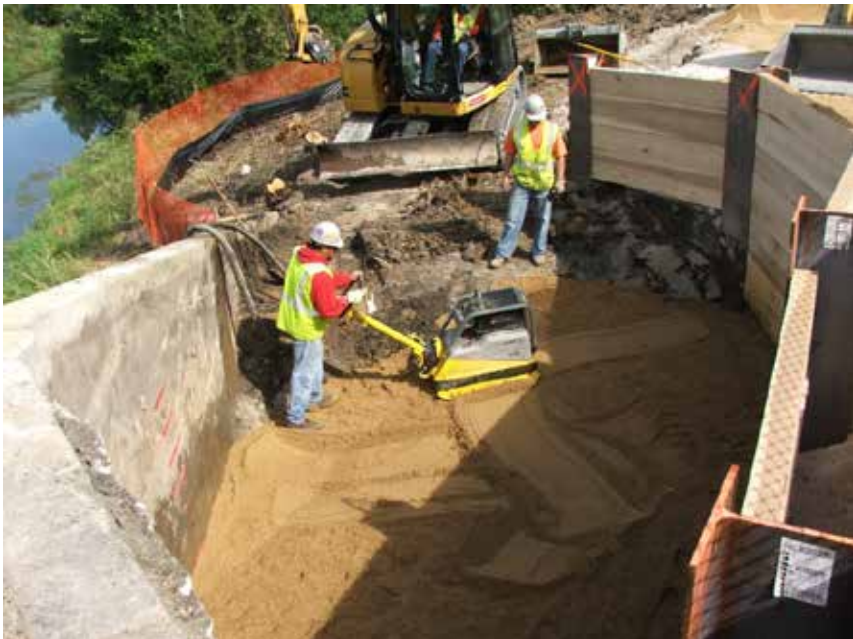
CLIENT: WCERT	SITE NAME: Kress Creek/West Branch DuPage River
PROJECT #: B0071043.0000	SITE LOCATION: DuPage County, IL
PHOTOGRAPH #: 21

DATE: 9/26/12	
DIRECTION: Northeast	
COMMENT: Backfill and compaction in the northeast corner (R3B-25) of the Route 59 Bridge Area.

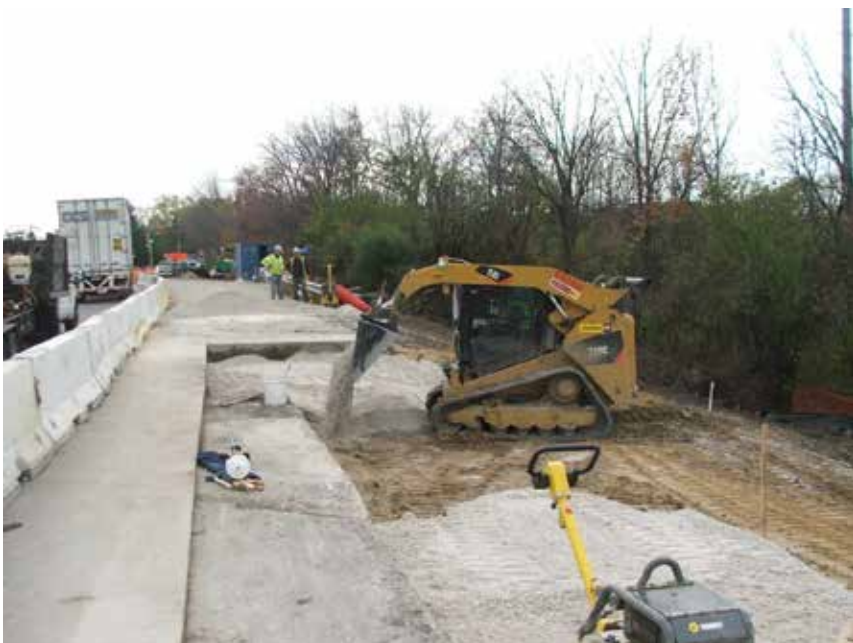
CLIENT: WCERT	SITE NAME: Kress Creek/West Branch DuPage River
PROJECT #: B0071043.0000	SITE LOCATION: DuPage County, IL
PHOTOGRAPH #: 22

DATE: 10/11/12	
DIRECTION: West	
COMMENT: Backfill of asphalt subbase in northwest corner (R3B-23) of Route 59 Bridge Area.

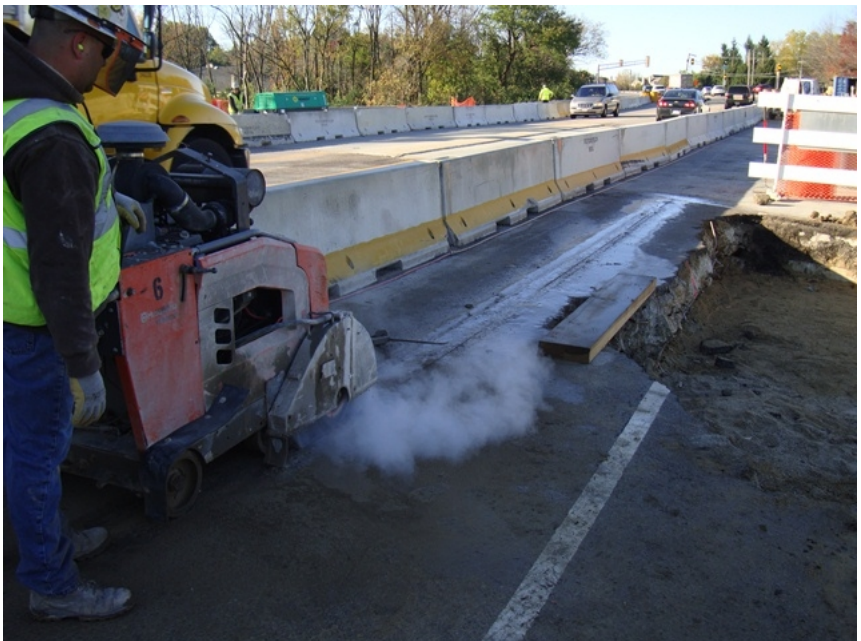
CLIENT: WCERT	SITE NAME: Kress Creek/West Branch DuPage River
PROJECT #: B0071043.0000	SITE LOCATION: DuPage County, IL
PHOTOGRAPH #: 23

DATE: 10/10/12	
DIRECTION: West	
COMMENT: Sawcutting of existing asphalt and concrete in northeast corner (R3B-25) of the Route 59 Bridge Area.

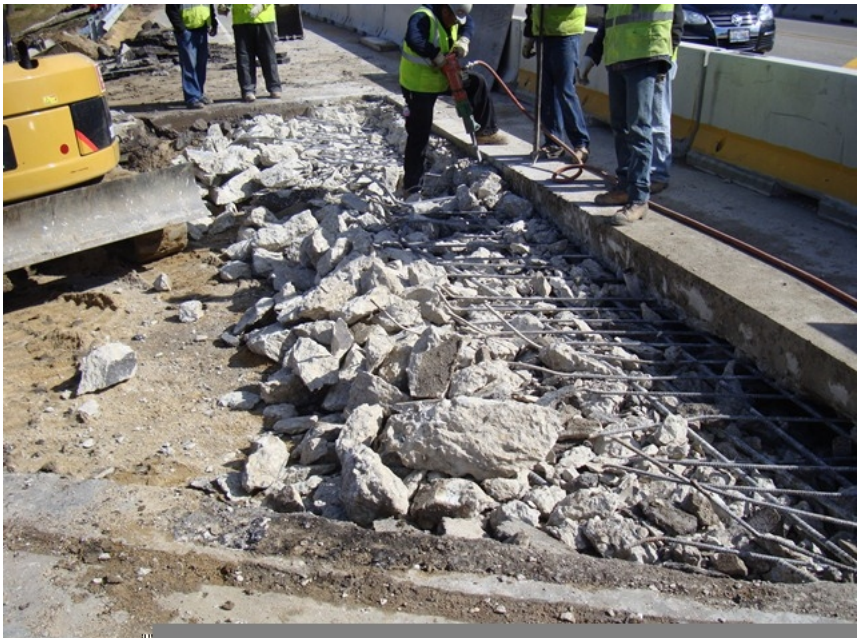
CLIENT: WCERT	SITE NAME: Kress Creek/West Branch DuPage River
PROJECT #: B0071043.0000	SITE LOCATION: DuPage County, IL
PHOTOGRAPH #: 24

DATE: 10/10/12	
DIRECTION: East	
COMMENT: Removal of existing concrete to expose steel reinforcement in northeast corner (R3B-25) of Route 59 Bridge Area.

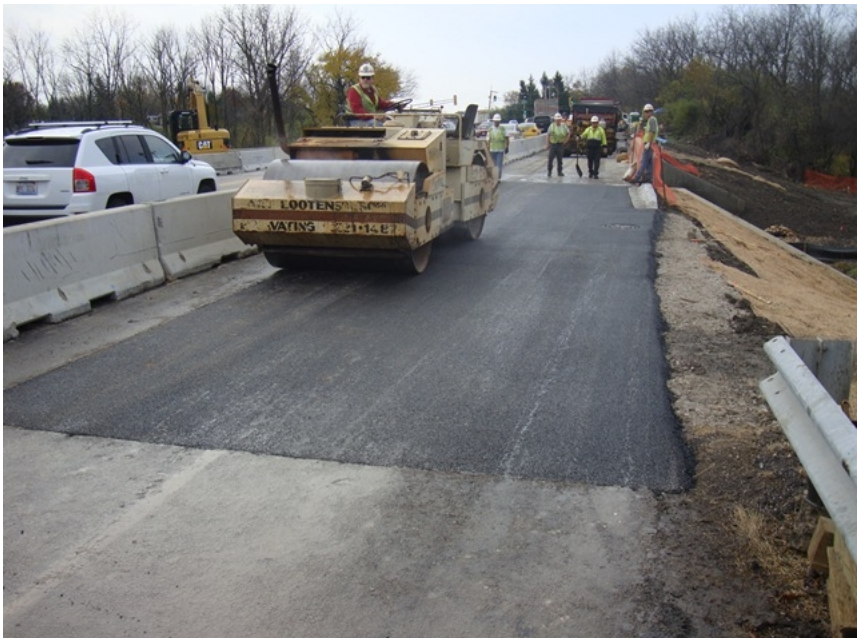
CLIENT: WCERT	SITE NAME: Kress Creek/West Branch DuPage River
PROJECT #: B0071043.0000	SITE LOCATION: DuPage County, IL
PHOTOGRAPH #: 32

DATE: 10/24/12	
DIRECTION: West	
COMMENT: Asphalt compaction in northeast corner (R3B-25) of Route 59 Bridge Area.

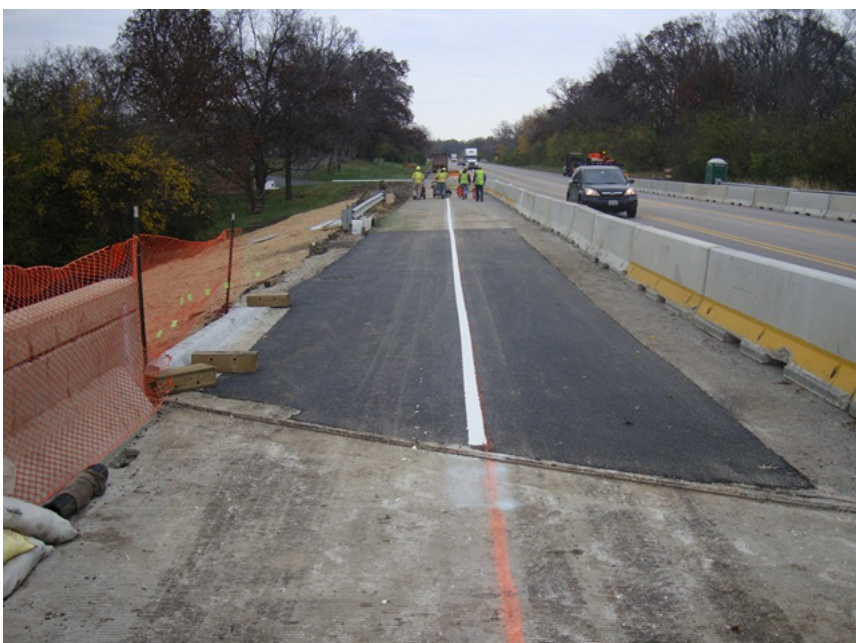
CLIENT: WCERT	SITE NAME: Kress Creek/West Branch DuPage River
PROJECT #: B0071043.0000	SITE LOCATION: DuPage County, IL
PHOTOGRAPH #: 34

DATE: 10/25/12	
DIRECTION: East	
COMMENT: Thermoplastic striping installation through work area at the Route 59 Bridge Area.

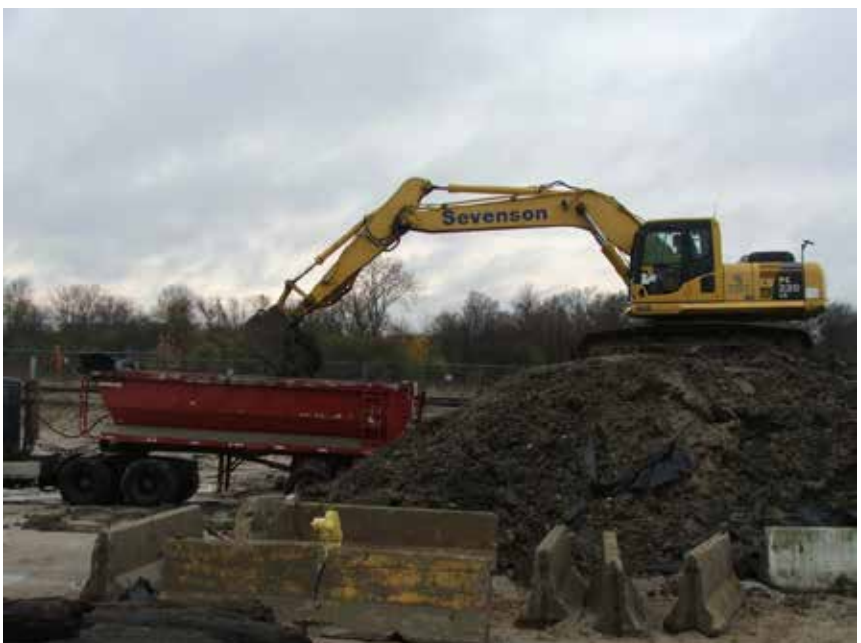
CLIENT: WCERT	SITE NAME: Kress Creek/West Branch DuPage River
PROJECT #: B0071043.0000	SITE LOCATION: DuPage County, IL
PHOTOGRAPH #: 38

DATE: 10/22/12	
DIRECTION: North	
COMMENT: Load-out of overburden material from the Rare Earths Facility to Waste Management Landfill.

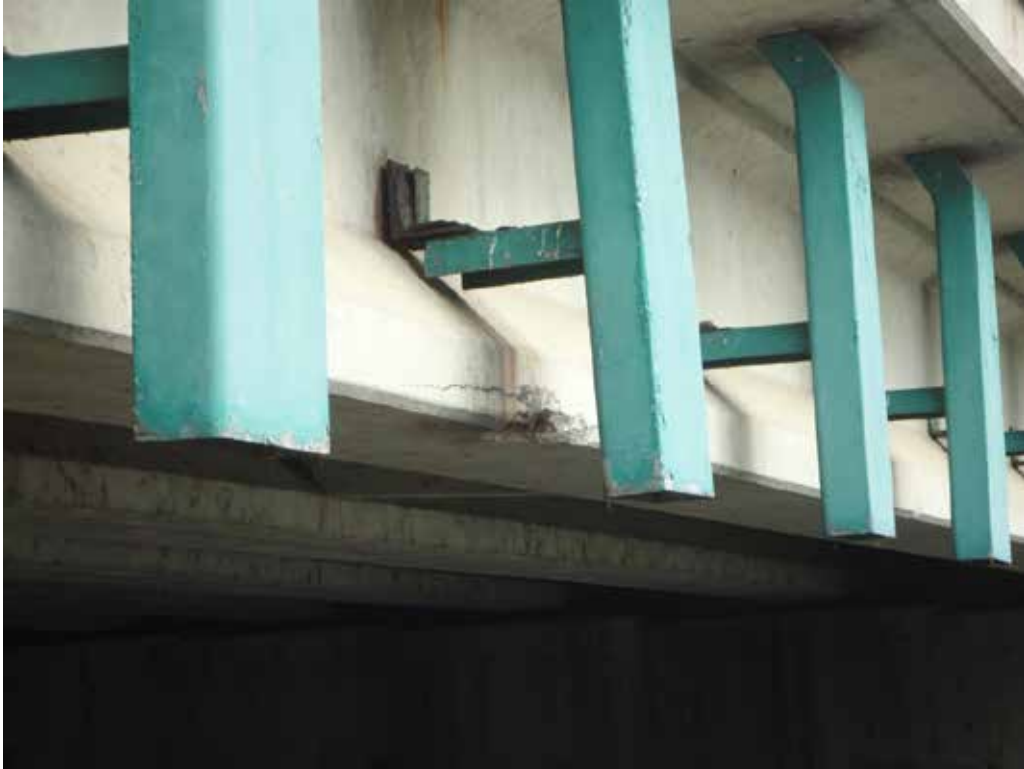
SW-03: Zoom of I-Beam Spall

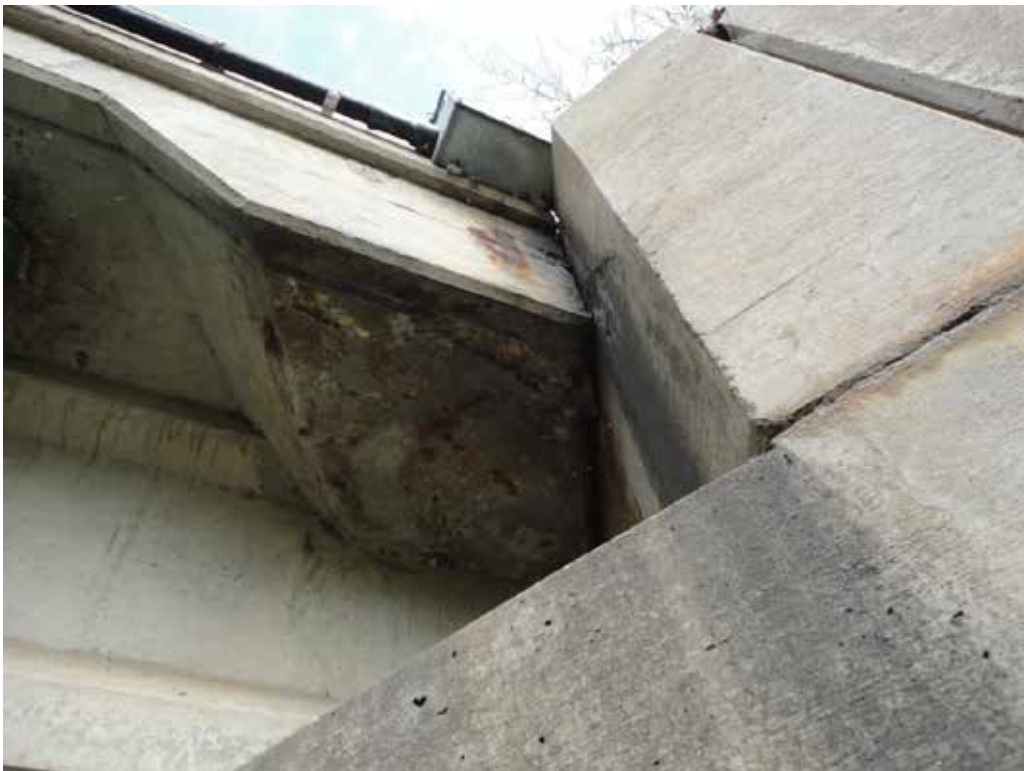
SE-08: Southeast Bridge Deck (1 of 4)

In this location, there were no signs of cracks in the wing wall (picture SE-03). The EJ between the wing wall and abutment showed signs of movement. The EJ did not appear to be a uniform width. The wing wall also appeared to lean slightly towards the roadway. The EJ between the wing wall and abutment was estimated to be 1-inch wide at the bottom and 1 1/2-inches at the top. The wing wall was estimated to be flush with the face of the abutment at the bottom and 2-inches in at the top. The abutment appeared to be in good condition. There were two horizontal cracks, which did not appear to affect the integrity of the abutment. From this location, the parapet appeared to be in good overall condition and from the distance viewed of the parapet elevation, no cracks were apparent. There appeared to be slight corrosion on the underside at the corner of the bridge deck (picture SE-08). At the end of the parapet, a horizontal crack was apparent.

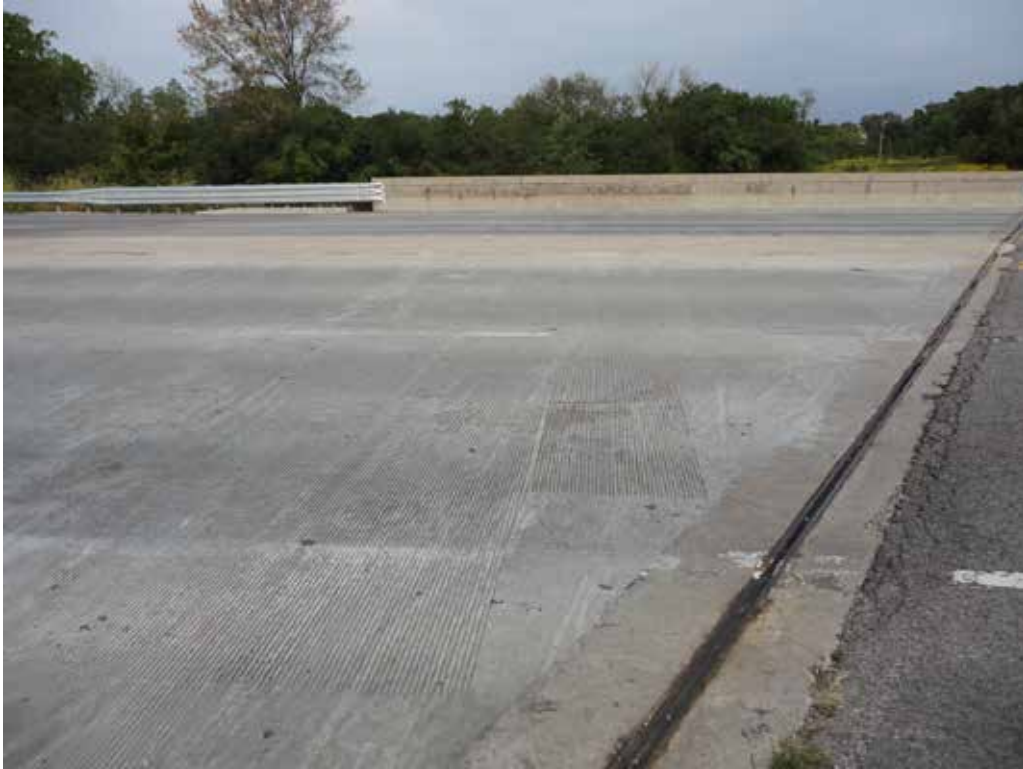
SE-11: Southeast Bridge Deck (4 of 4)

Overall, the bridge appeared to be in same condition as observed in the pre-construction assessment. The bridge showed no signs of movement or settling during the construction phase. There were no signs of additional cracking on the bridge, bridge abutment, or bridge wing walls. The expansion joints between the wing wall and bridge abutments, and the expansion joint between the bridge and the approach slabs appeared to be in the same condition and width as observed in the pre-construction assessment. The Attachment B photo log represents the condition observed during the post-construction condition assessment. Post-construction photos were intended to be taken at the same locations as the pre-construction photos. Three photos that were taken during the pre-construction assessment were not captured during the post-construction assessment (photos SE-11, SW-03, NE-06, and NE-09).

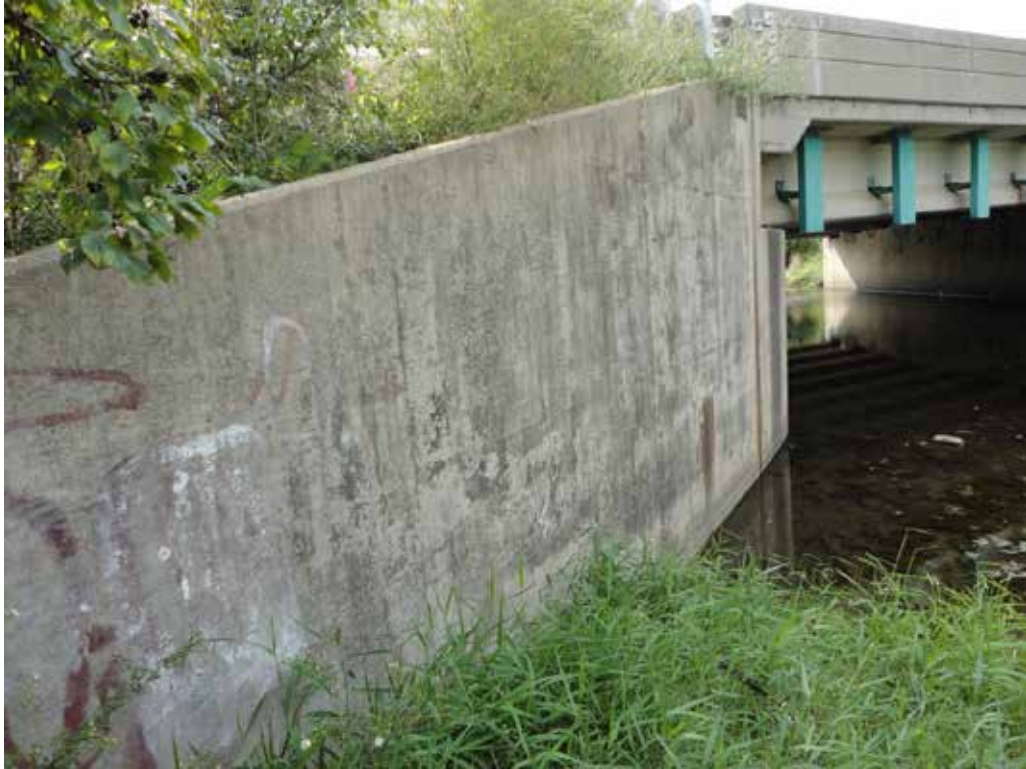
NE-01: Northeast Wing Wall (1 of 2)

In this location, there were no signs of cracks in the wing wall (picture NE-01). The EJ between the wing wall and abutment showed slight signs of movement. The EJ appeared to be a uniform width. The wing wall also appeared to lean slightly towards the roadway. The EJ was estimate to be 1-inch wide. The wing wall was estimated to be flush with the face of the abutment at the bottom and 2-inches in at the top. The abutment appeared to be in good condition. From this location, the parapet appeared to be in good overall condition and from the distance viewed of the parapet elevation, no cracks were apparent.

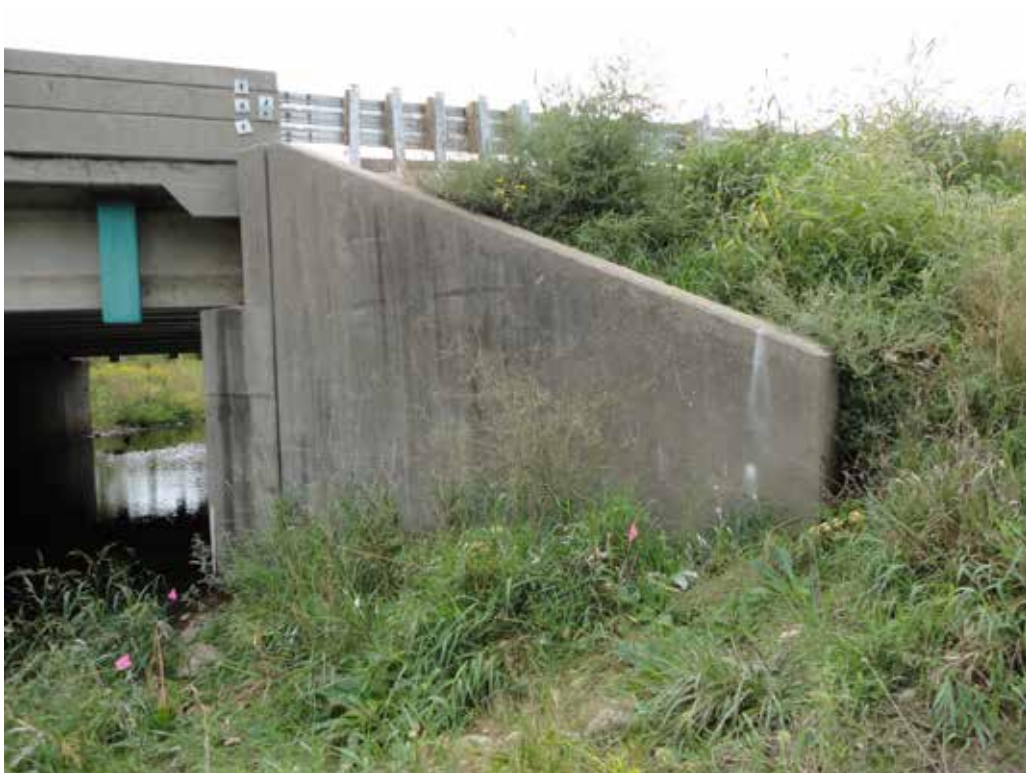
NW-04: Northwest Wing Wall

In this location, there were no signs of cracks in the wing wall (picture NW-04). The EJ between the wing wall and abutment showed signs of movement. The EJ did not appear to be a uniform width. The wing wall also appeared to lean slightly towards the roadway. The EJ between the wing wall and abutment was estimated to be 1/2-inch wide at the bottom and 1 1/2-inches at the top. The wing wall was estimated to be flush with the face of the abutment at the bottom and 1 inch in at the top. The abutment appeared to be in good condition. The abutment appeared to be in good condition. There were two horizontal cracks, which did not appear to affect the integrity of the abutment. From this location, the parapet appeared to be in good overall condition and from the distance viewed of the parapet elevation, no cracks were apparent.

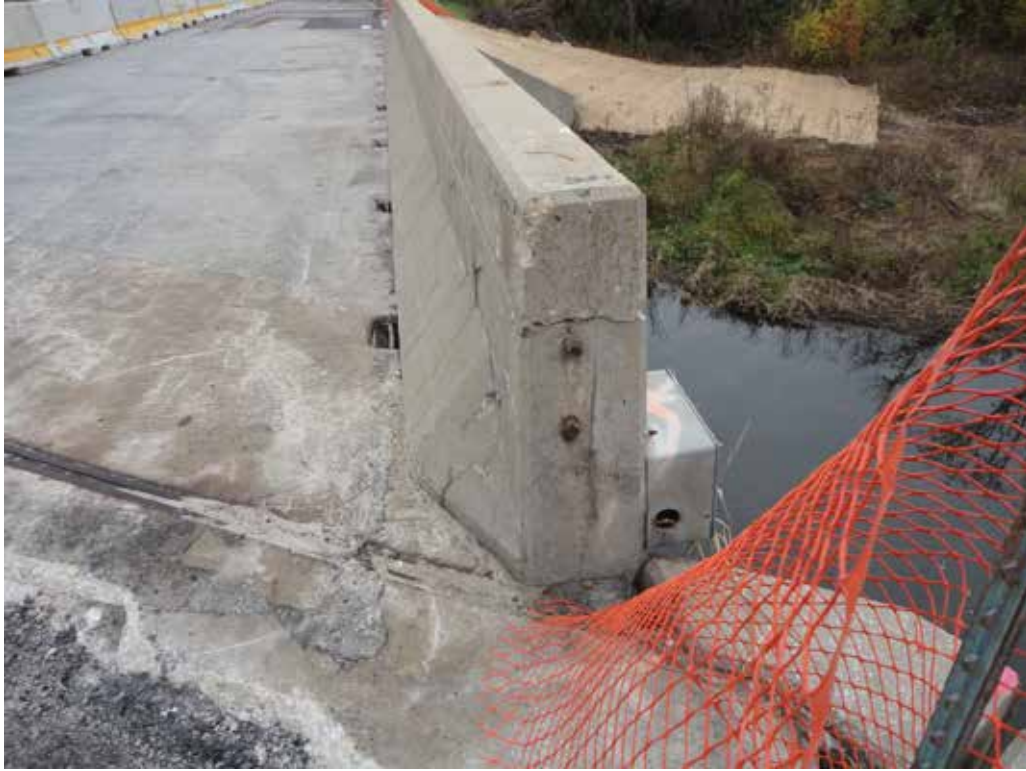
SW-11: Southwest Parapet

abutment at the bottom of the wall and 4 inches at the top. The abutment appeared to be in good condition. There were two horizontal cracks, which did not appear to affect the integrity of the abutment. From this location, the parapet appeared to be in good overall condition and from the distance viewed of the parapet elevation, no cracks were apparent. At the end of the parapet, a horizontal crack was apparent (picture SW-11).
